## INNOVATIVE APPROACHES TO MITIGATE CLIMATE IMPACT IN BUILT ENVIRONMENTS: LABORATORY INVESTIGATIONS OF SALT CRYSTALLISATION IN CULTURE AND HERITAGE CONSERVATION

Mohd Jaki Mamat<sup>1</sup>, Siti Norbaya Mohd Konar<sup>2\*</sup> and Shaari Mat Saod<sup>2</sup>

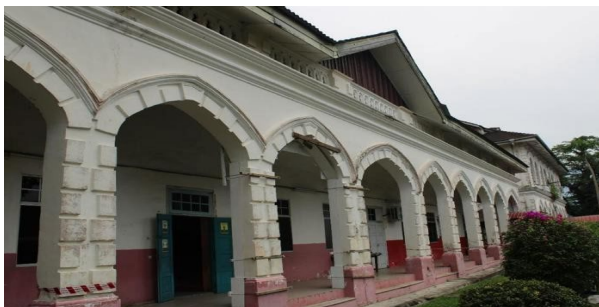
Figure 2: Visual Inspection of the Corridors Area

This section outlines the systematic steps to prepare materials for assessing salt content in heritage buildings. The observed deterioration patterns and sampling locations identified during the initial site inspection are illustrated in figures 2 to 11.

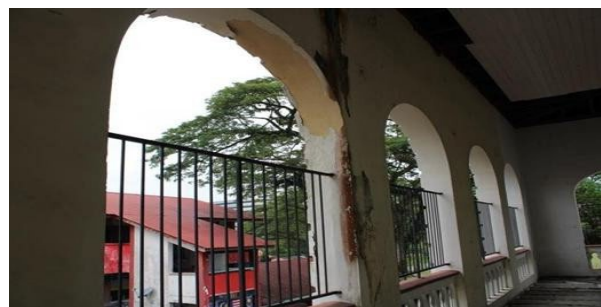
Figure 3: Visual Inspection of the Corridors Area

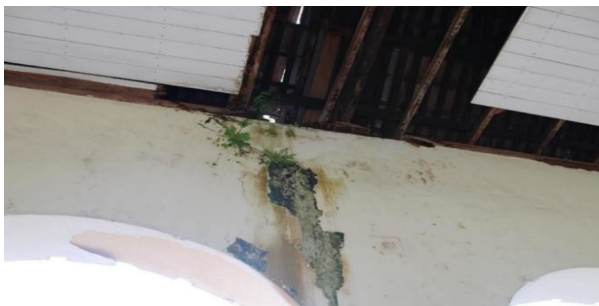
Figure 4: Visual Inspection of the Corridors Area

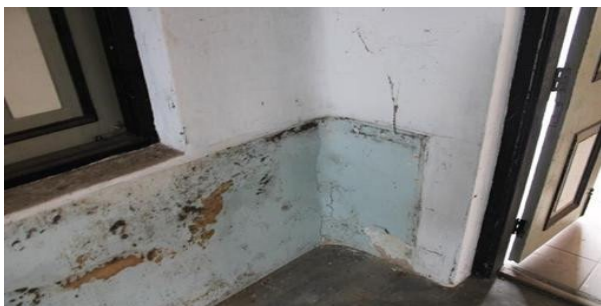
Figure 5: Visual Inspection in the Class Area

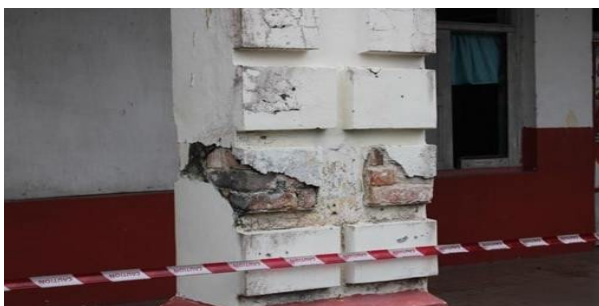
Figure 6: Visual Inspection of the Corridors Area

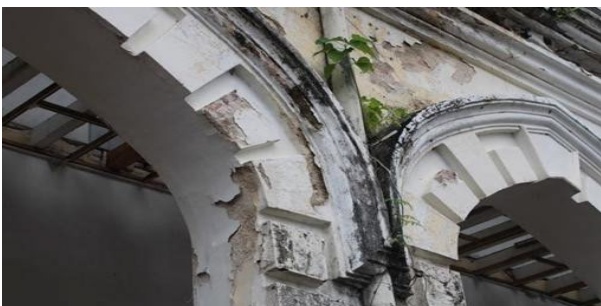
Figure 7: Visual Inspection of the Corridors Area

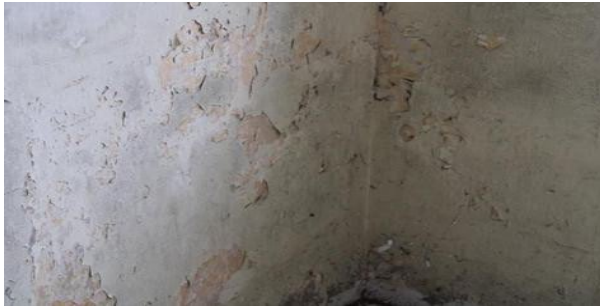
Figure 8: Visual Inspection of the Corridors Area

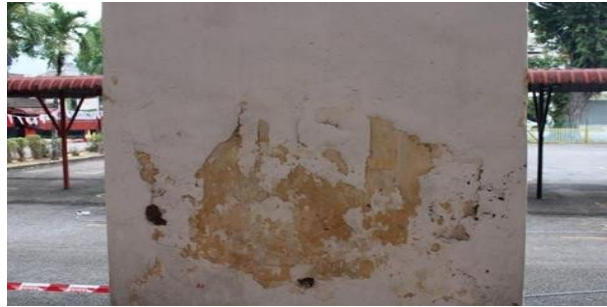
Figure 9: Visual Inspection of the Corridors Area

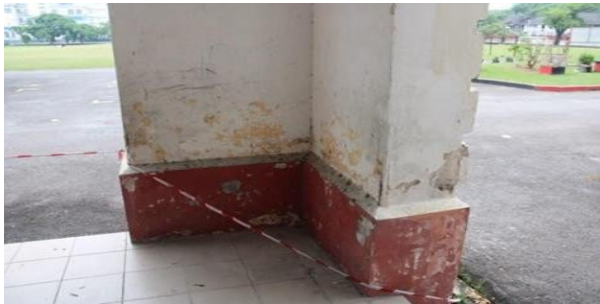
Figure 10: Visual Inspection of the Corridors Area

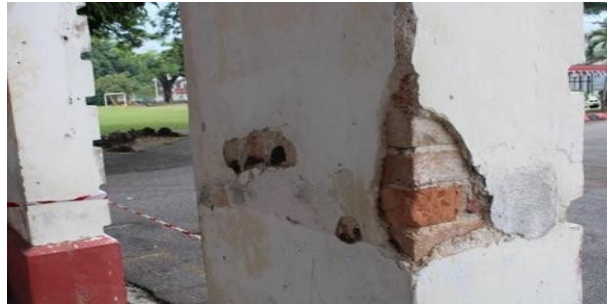
Figure 11: Visual Inspection of the Corridors Area

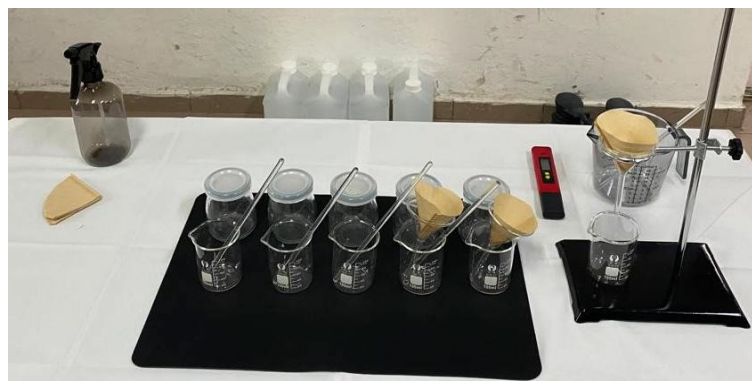
Figure 12: Equipment Used for Data Preparation

Ensure that all equipment, containers, and solvents used in the sample preparation process are clean and free from contaminants. Use blanks (solvent without sample) to check for any background contamination. Figure 12 shows the equipment used for data preparation

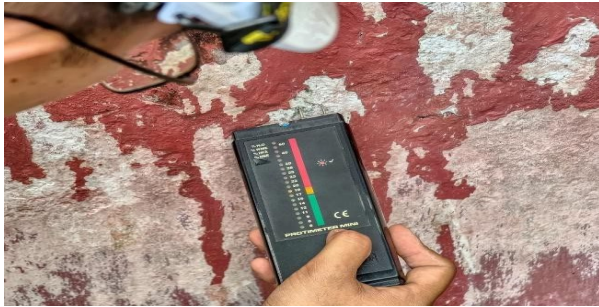
Figure 13: Measure the Moisture Content Before Pointing the Place to take the Materials

Representative samples should be systematically selected and collected from various locations within the heritage building, with particular attention to areas susceptible to salt crystallisation. These include walls, plasters, and other masonry materials. The precise location and condition of each sample should be meticulously documented, a process referred to as mapping. The presence of salt in building materials plays a critical role in influencing their moisture content, as salts possess hygroscopic properties that attract and retain moisture. This process can result in the crystallisation of salt, leading to significant material damage and degradation over time. When collecting samples for ion chromatography (IC) analysis, priority should be given to areas within the building exhibiting elevated moisture content. The moisture assessment activities and the identification of sampling locations are illustrated in figures 13 and 14.

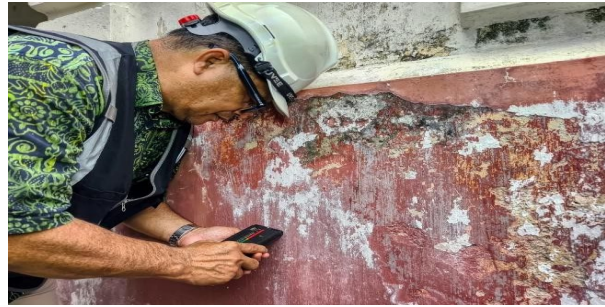
Figure 14: Assist by Conservator to Measure the Moisture

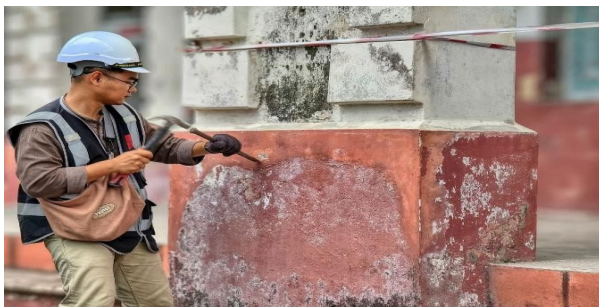
Figure 15: Crushing the Point Selected to Collect the Sample

Gently clean the surface of the samples to remove any loose debris, dust, or contaminants that could affect the analysis. Use a soft brush or a lint-free cloth to avoid introducing new contaminants. If the samples are solid, such as pieces of plaster or brick, they need to be crushed and ground into a fine powder. Use a mortar and pestle or a mechanical grinder to achieve a consistent and fine powder. This increases the surface area and ensures a more efficient extraction of salts. The sample extraction and material crushing procedures are illustrated in figures 15 to 18.

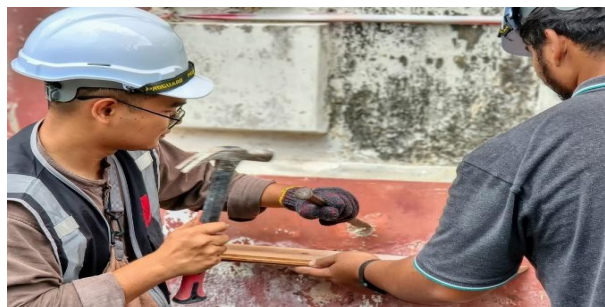
Figure 16: Crushing the Point Using the right Technique and Tools

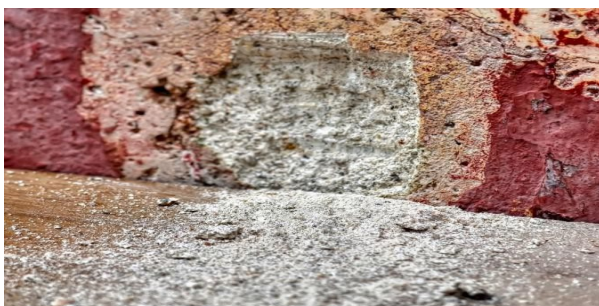
Figure 17: Hold the Sample Using Clean Board to Avoid Sample Fell to the Floor

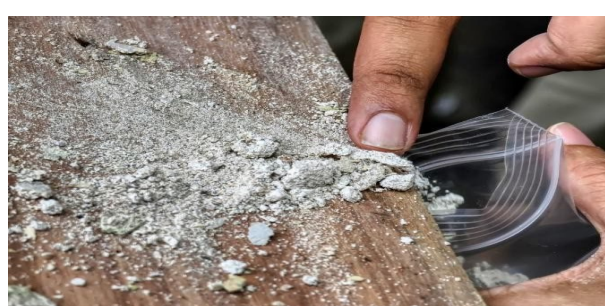
Figure 18: Collect Specific Amount of Sample and Put in the Zip Bag with Tagging

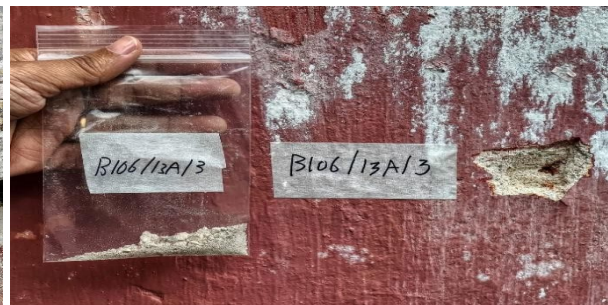
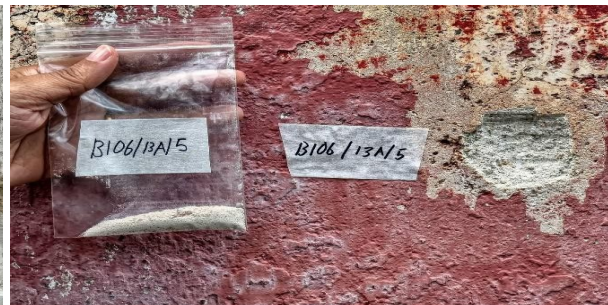
Figure 19: Tagging Process

Figure 20: Tagging Sample 1

Figure 21: Tagging Sample 2

Figure 22: Tagging Sample 3

Figure 23: Tagging Sample 4

Figure 24: Tagging Sample 5

Five sampling locations were selected from areas exhibiting visible signs of moisture-related deterioration. Location B106/13A/1 was situated at the lower corridor wall adjacent to an external drainage channel. Location B106/13A/2 was located near a wall-floor junction showing severe efflorescence. Location B106/13A/3 was sampled from an internal classroom wall affected by rising damp. Location B106/13A/4 represented the most severely deteriorated masonry section with extensive

plaster detachment and salt deposits. Location B106/13A/5 was collected from a corridor column base exposed to frequent rain splash. The tagging, sample identification, and collection procedures for all sampling locations are illustrated in Figures 19 to 24.

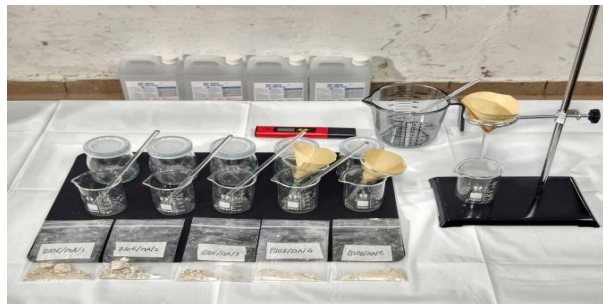
Figure 25: Organized The Sample Before Proceed to the Next Step

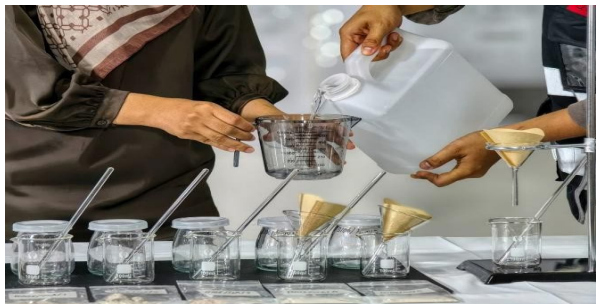
Figure 26: Place Deionized Water into Measured Jug to Easy Put in the Beaker (20 ml)

Prepare a solvent, typically high-purity deionized water (DI water), to extract soluble salts from the collected heritage material samples. The solvent plays a critical role in ensuring the reliability and accuracy of the ion chromatography (IC) analysis, as any background ionic contamination may significantly distort the analytical results. Therefore, laboratory-grade deionized water with a resistivity of at least  $\geq 18 \text{ M}\Omega \cdot \text{cm}$  should be used to minimize the presence of residual ions such as chloride, nitrate, sulphate, or carbonate that could interfere with detection and quantification. Prior to extraction, the deionized water should be tested as a blank sample using the ion chromatography system to verify that it produces negligible or undetectable background ion signals. This blank verification step ensures that any detected ions in subsequent analyses originate solely from the heritage material samples and not from the solvent itself. The solvent must be stored in clean, chemically inert containers such as polypropylene or borosilicate glass bottles that have been pre-rinsed with deionized water to eliminate contamination risks. Strict laboratory handling protocols should be observed during solvent preparation, including the use of powder-free gloves, sterilized measuring cylinders, and contamination-free stirring rods. All containers used for extraction must be thoroughly cleaned and dried prior to use. It is also recommended to prepare the solvent immediately before extraction to reduce the possibility of

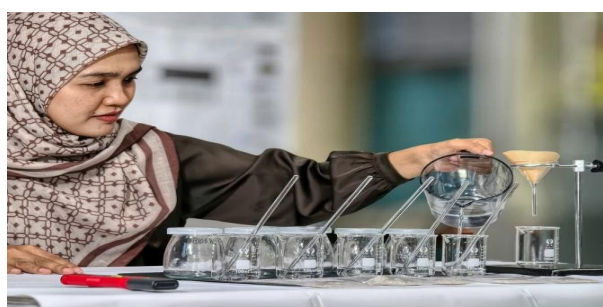
Figure 27: Place Deionized Water in the Beaker (20 ml)

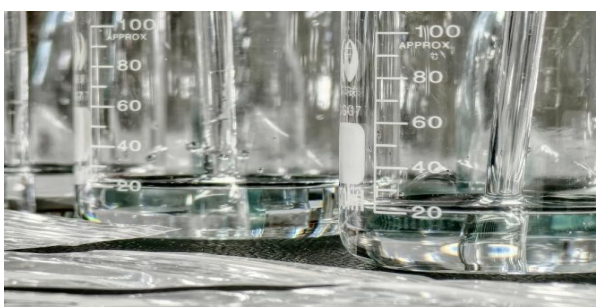
Figure 28: Deionized Water in the Beaker (20 ml)

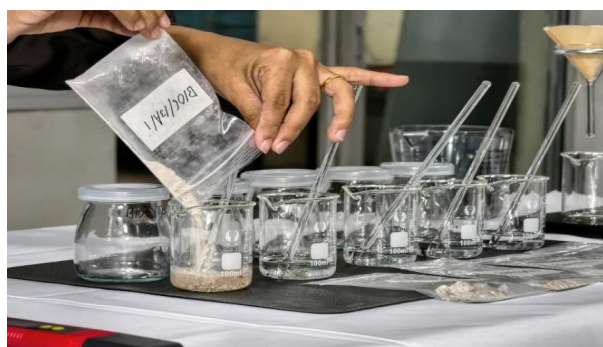
Figure 29: Place Specific Amount of the Sample in the Beaker with Deionized Water (20 ml)

Place the weighed samples into clean, inert containers (e.g., plastic or glass beakers). Add an appropriate amount of solvent to each container (10 ml of deionized water per gram of sample). Stir or shake the mixture gently to ensure thorough contact between the solvent and the sample. Allow the samples to soak in the solvent for a sufficient period, usually 24-48 hours, to ensure complete extraction of the salts. After the extraction period, filter the solution to remove any undissolved particles. Use fine filter paper or a membrane filter with an appropriate pore size (e.g., 0.45 micrometres) to ensure that only the liquid containing dissolved salts passes through. Collect the filtrate in a clean container and check the pH level before placing the solution in the clean bottle. The soaking, filtration, pH measurement, and filtrate preservation procedures are illustrated in Figures 29 to 35.

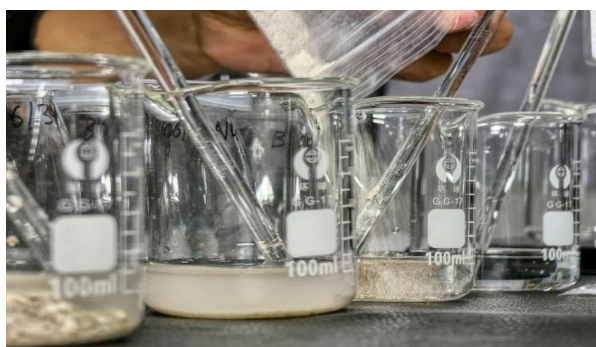
Figure 30: Sample in the Beaker with Deionized Water (20 ml)

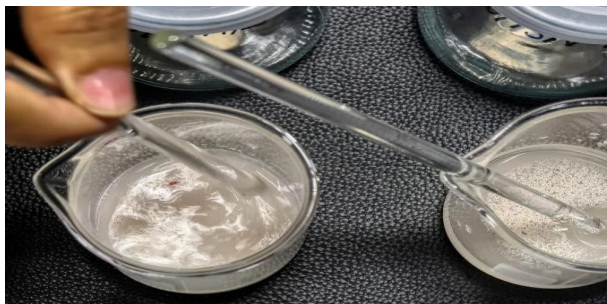
Figure 31: Stir the Sample in the Beaker with Deionized Water (20 ml)

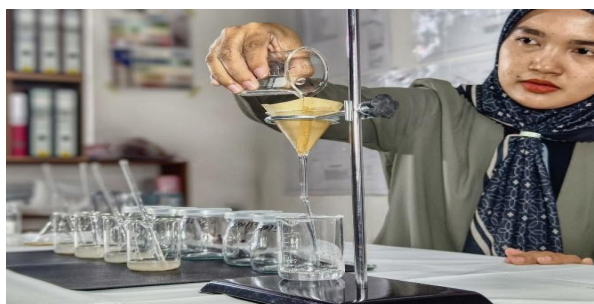
Figure 32: Filter the Solution to Remove any Undissolved Particles

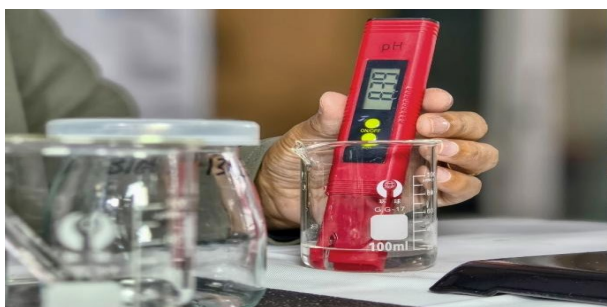
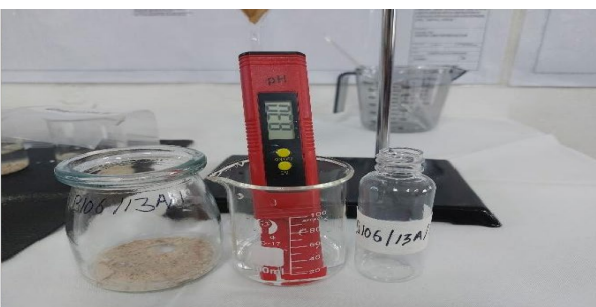
Figure 35: Check the Ph Level Before Place the Solution in the Clean Bottle

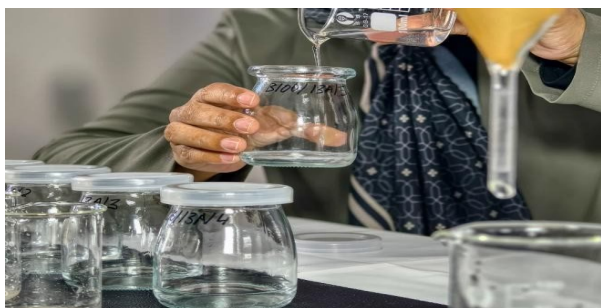
Figure 36: Place Solution into the Clean Bottle

After filtration, the extracted solutions were transferred into clean, labelled containers for storage and subsequent ion chromatography analysis. Proper labelling is important to avoid sample misidentification and to maintain the integrity and reliability of the laboratory results. The transfer of filtered solutions into storage containers and the sample bottle labelling procedures are illustrated in Figures 36 and 37.

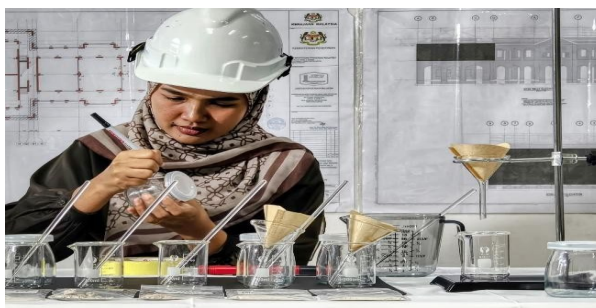
Figure 37: Tagging Sampling Bottle

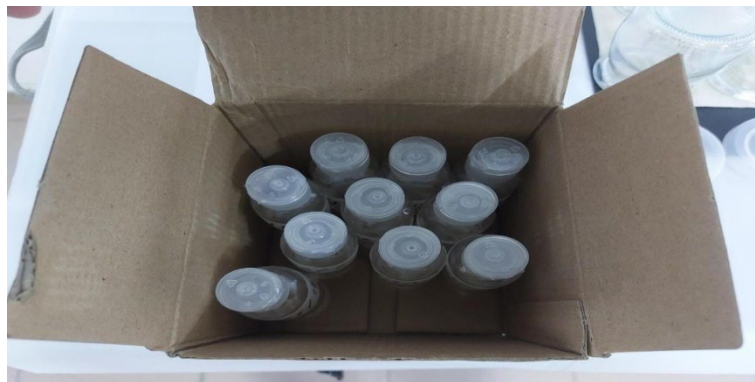
Figure 38: Preserve The Filtrate by Storing It in Clean, Airtight Containers

If immediate analysis is not possible, preserve the filtrate by storing it in clean, airtight containers. Refrigerate the samples if necessary to prevent any changes in their composition. These steps ensure that the samples are prepared accurately and consistently, providing reliable data for the subsequent chromatography analysis. Proper sample preparation is crucial for obtaining accurate and meaningful results that can inform effective conservation strategies. The final sample preservation and storage procedures are illustrated in Figure 38

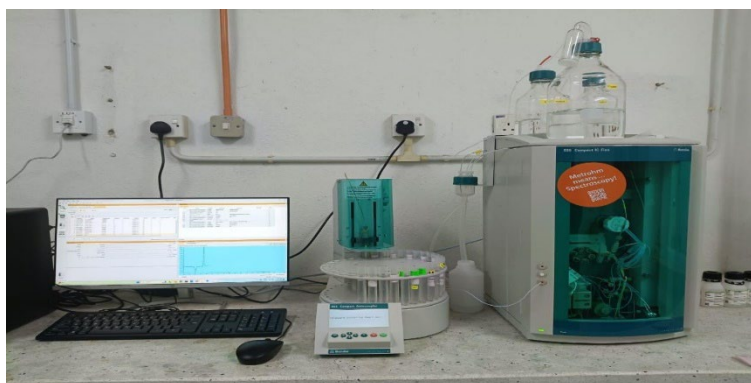
Figure 39: Setup Instrument for Ion Chromatography Testing

This section describes the ion chromatography (IC) system and analytical procedures used to determine the concentration of soluble salts present in the heritage building materials. Ion chromatography was selected because it provides accurate, reliable, and sensitive quantification of ionic species commonly associated with salt deterioration, including chloride, nitrate, sulphate, fluoride, and nitrite ions. The analytical procedures included instrument calibration, preparation of standards and blanks, sample injection, chromatographic separation, data acquisition, and post-analysis verification. The ion chromatography instrument used for the laboratory analysis is illustrated in Figure 39.
